ASBESTOS AND REGULATED WASTE INSPECTION REPORT

Chisago County Jail Buildings 109/111 North Main Street Chisago, MN 55012

AET Project No. P-0013158

Report Date: October 14, 2022

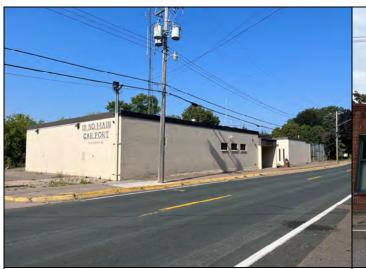
Photo 1 – The 111 North Main Street jail building looking northwest.

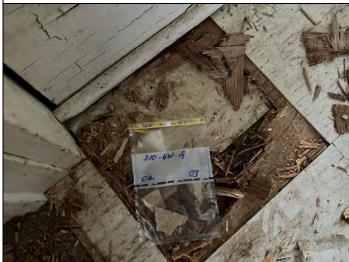
- Sample 310-HW-A, Photo 3: 12" white floor tile and black mastic in the 109 (House) building was found to contain 3% chrysotile asbestos in the mastic only, the tile DOES NOT contain asbestos. Approximately 180 square feet (SF) was identified in the House Floor 02 Room 03.

Photo 3 – Sample 310-HW-A, 3% asbestos containing black mastic on 12" white floor tile in the 109 building. Only the mastic contains.

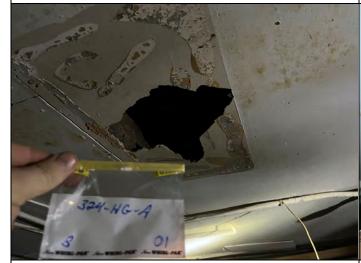
- Sample 324-HG-A, Photo 5: Gray cement board in the 109 (House) building was found to contain 15% chrysotile asbestos. Approximately 513 total SF was identified in the House Basement Rooms 01 (397 SF), 02 (30 SF), 03 (30 SF), 05 (16 SF), and 06 (40 SF).

Photo 5 – Sample 324-HG-A, 15% asbestos containing gray cement board in the 109 building.

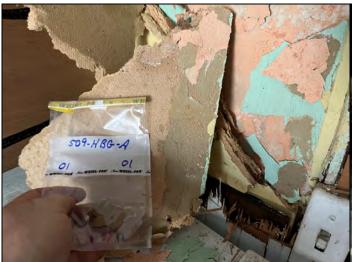
- Sample 509-HBG-A, Photo 7: Beige adhesive in the 109 (House) building was found to contain 3% chrysotile asbestos. Approximately 1,160 total SF was identified in the House Floor 01 Rooms 01 (560 SF), and 03 (600 SF).

Photo 7 – Sample 509-HBG-A, 3% asbestos containing beige adhesive in the 109 building.

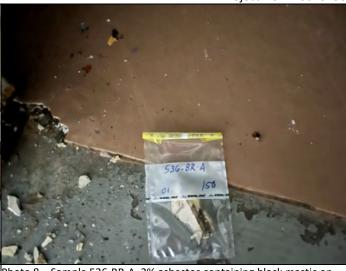
- Sample 536-BR-A, Photo 8: Brown rubber flooring and black mastic in the 111 (Jail) building
 was found to contain 3% chrysotile asbestos in the mastic only, the rubber flooring DOES NOT
 contain asbestos. Approximately 150 total SF was identified in the Jail Floor 01 Room 150.

Photo 8 – Sample 536-BR-A, 3% asbestos containing black mastic on brown rubber flooring in the 111 building. Only the mastic contains.
